Manhole Inspection Summary

Manhole # S21E1_014MH

Location Address: **2630 ridgely-huron alley**

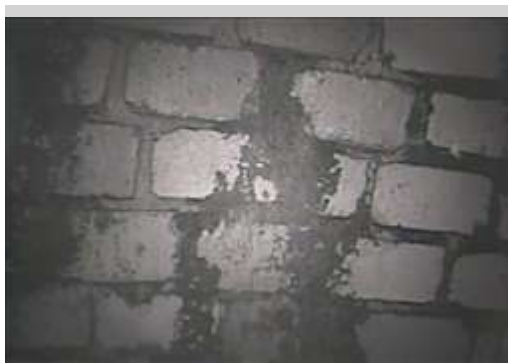
Defect 5

Infiltration: ☐ None ☐ Joint ☐ Cracks ☐ Mortar ☐ Roots ☒ **Wall**

infiltration @ barrel wall

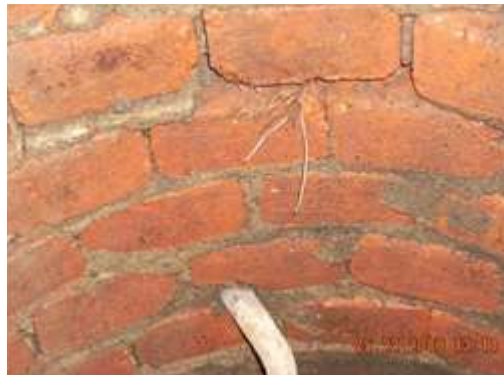
Defect 4

Condition: ☐ Sound ☐ Cracked ☒ **Root Intrusion** ☐ Loose Brick ☐ Deteriorated

root intrusion @ corbel wall

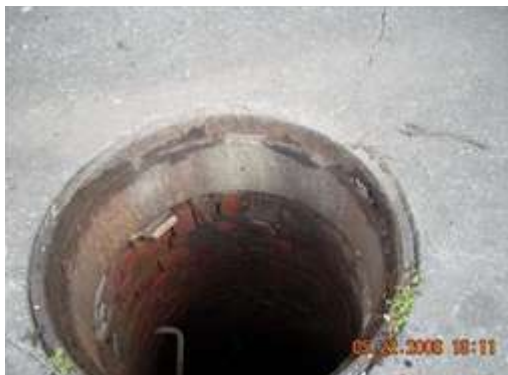
Defect 3

Subject To Ponding: **Sheeting**

inflow evidence from sheeting

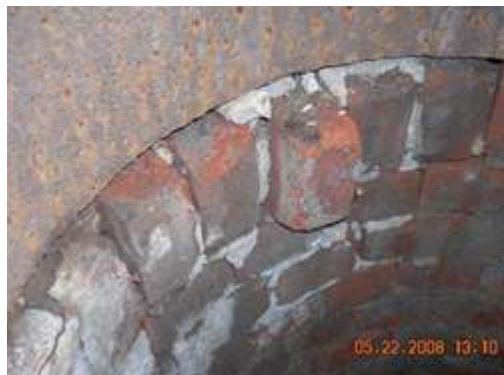
Defect 2

Condition: ☐ Sound ☐ Cracked ☐ Root Intrusion ☒ **Loose Brick** ☐ Deteriorated

loose chimney brick

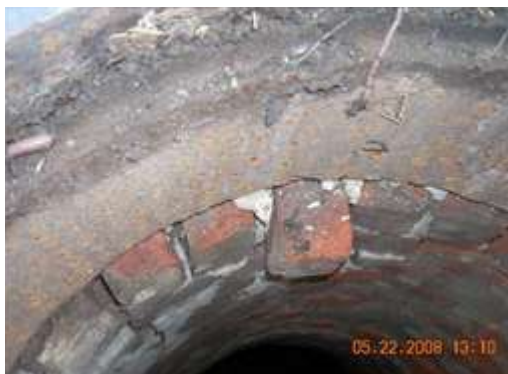
Defect 1

Frame Offset: **1** (in.)

frame offset

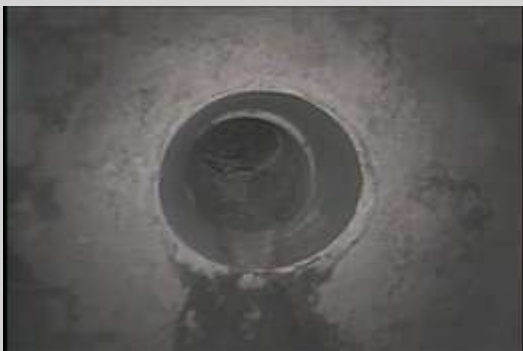
3 O'Clock Inflow

Pipe Height: **8.4** (in.) Rod and Bar (Angled)
Pipe Material: **Clay** ☐ Pipe Lined
Invert Depth: **9.65** (ft.) Flow Characteristics: **Fast**
Deposits: ☒ None ☐ Mud ☐ Sludge ☐ Debris ☐ Grease
Silt Depth: **0** (in.) Deposits Extent:
Infiltration: **Evidence** Pipe Seal Cond: **Sound**
